# THE MIAMI CONSERVANCY BULLETIN

JULY, 1922

PUBLISHED BY THE MIAMI CONSERVANCY DISTRICT  
DAYTON, OHIO

## Flood Prevention Proves Its Worth

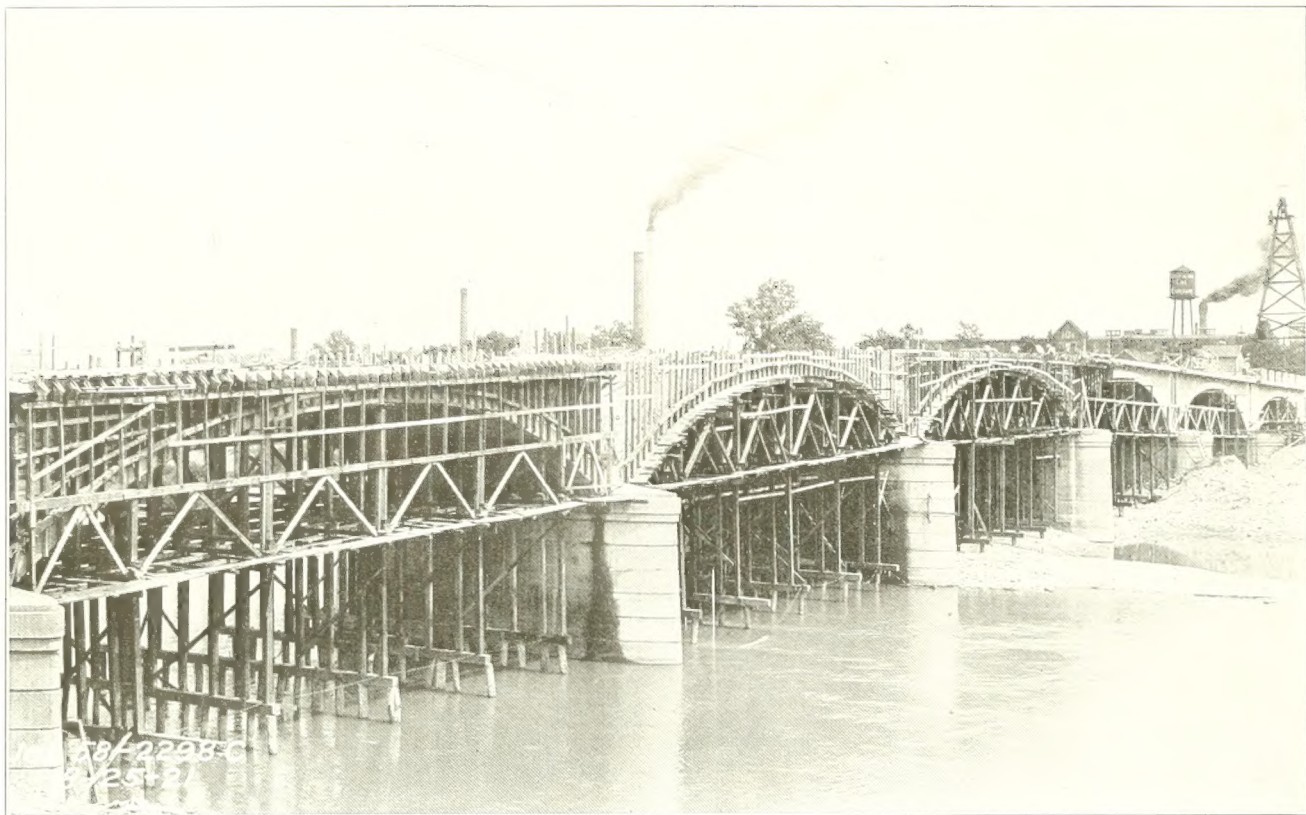
FIG. 364—BLACK STREET BRIDGE, HAMILTON, UNDER CONSTRUCTION AUGUST 8, 1921.

The arches are in various stages of completion. The one in the foreground has the full set of forms for the arch and spandrel walls in place. On the next two the forms are only partly in place. On the fourth and fifth only the skeleton frame work supporting the completed arch remains in place. On the last arch visible, the work is so far along that the posts for the railing are set. The form work is described elsewhere in this Bulletin. The wires overhead and the tower in the background are a part of the cableway used to transport materials and to handle forms.

The view is taken from the same position as Figure 364. The icicles on the under side of the arches mark the positions of the weep holes. The piling underneath has since been removed.
